PHASE I REPORT  
NATIONAL DAM INSPECTION PROGRAM

Name of Dam: STOVERS LAKE DAM, NDS NO. PA-00600  
State & State No. PENNSYLVANIA, 38-5  
County: LEBANON  
Stream: A BRANCH OF BRANDYWINE CREEK  
Date of Inspection: November 15, 1978

STOVERS LAKE DAM

NDS-ID NO. PA-00600

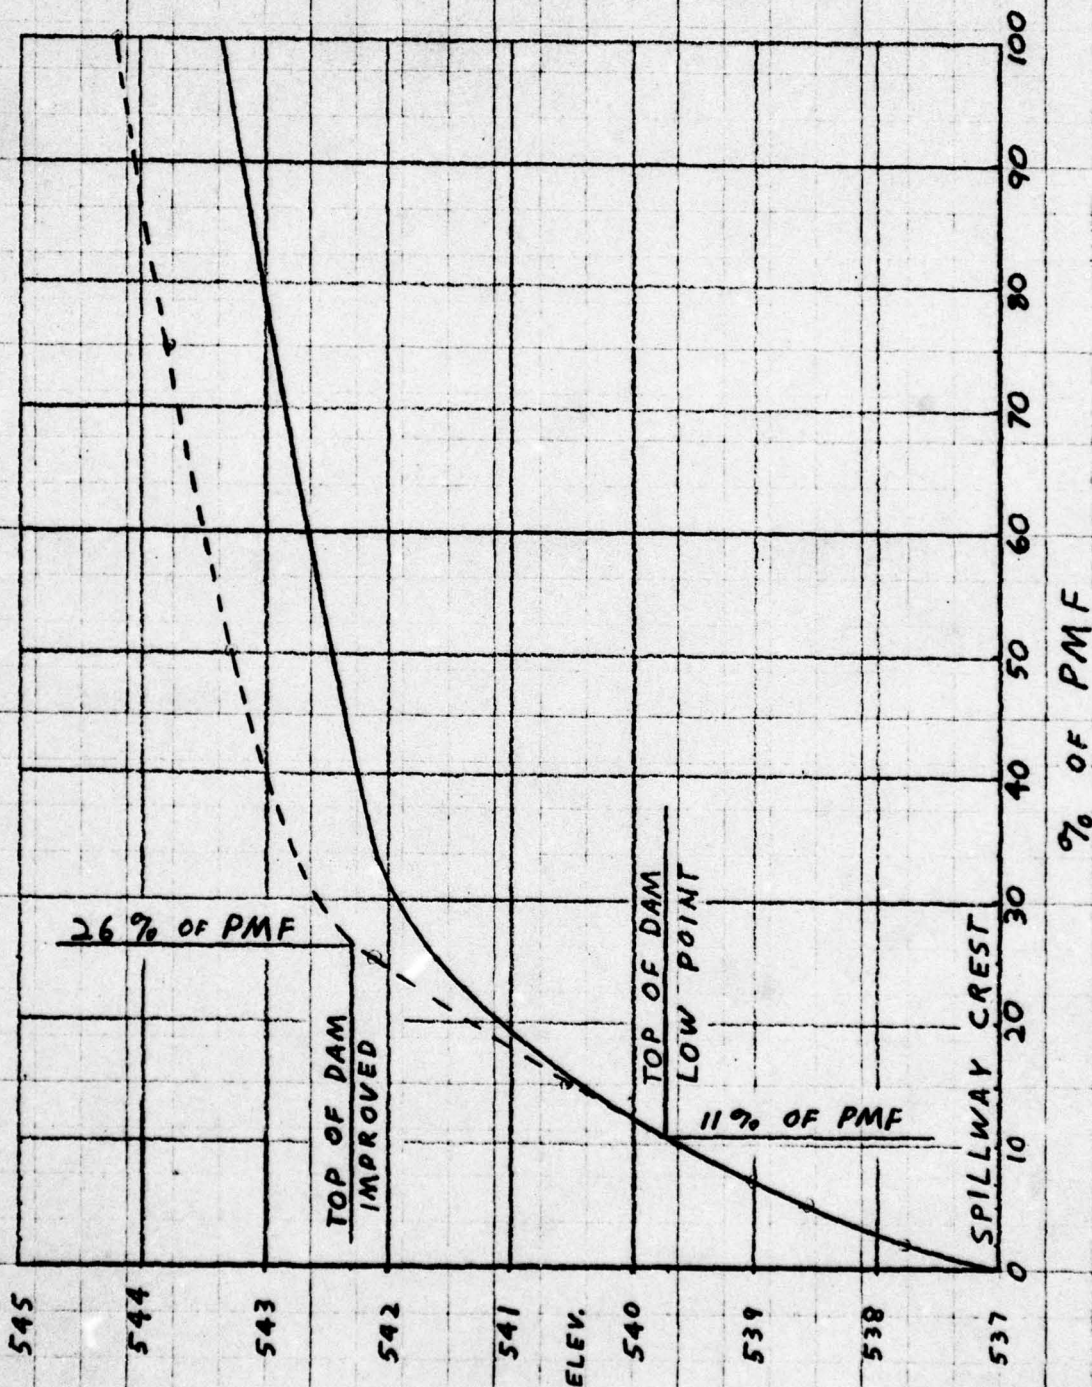
# SPILLWAY CAPACITY CURVE

————— EXISTING CONDITION  
----- LOW AREA FILLED IN
